REPORT NO. 2000036.401
REVISION: 0
PROJECT NO. 2000036.00
November 2020

Examination and Analysis of Equipment Involved in Mr. Justin Moore's June 8, 2017, Fall Incident

United States District Court
Northern District of Texas
San Angelo Division

Justin Moore and Judith Moore vs DB Industries, LLC, et al.

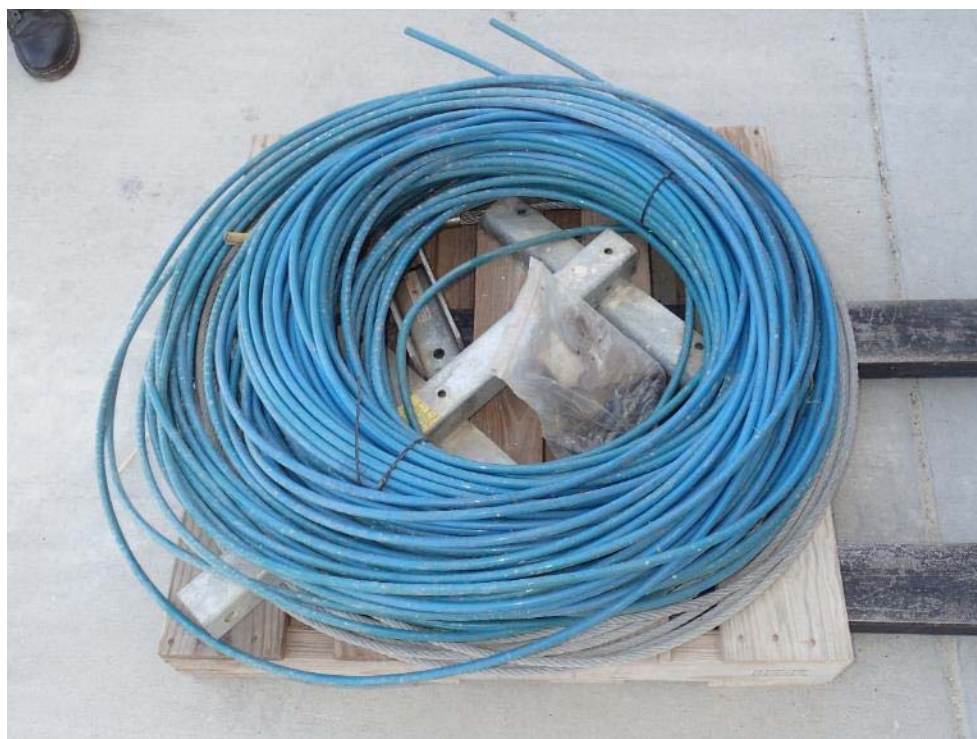
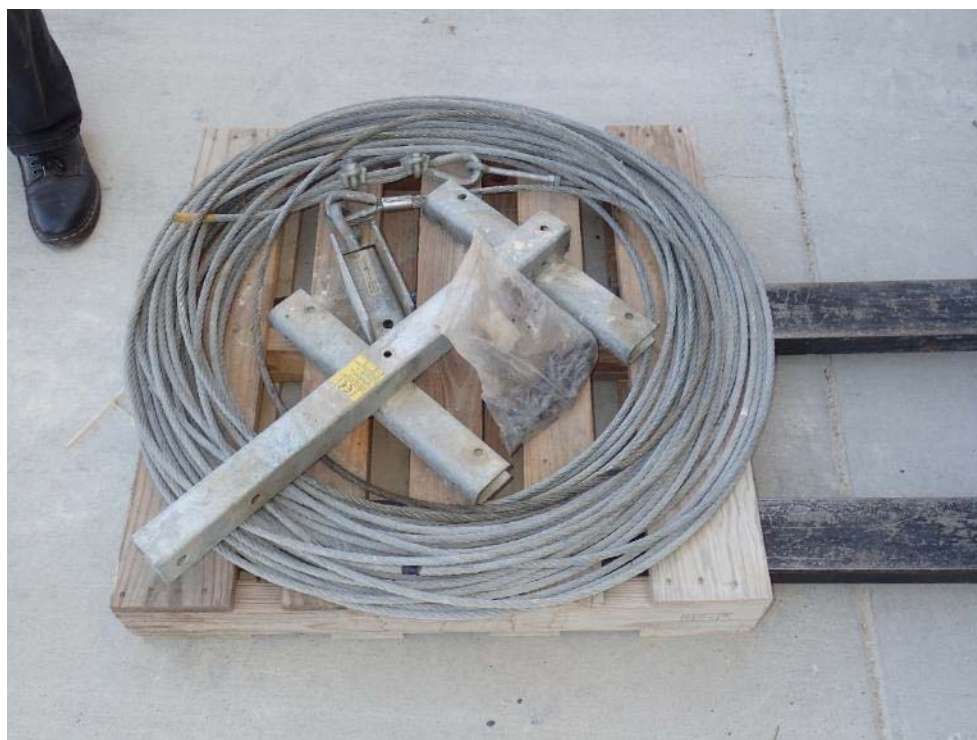
On the day of the site visit, access to locations above the base deck were not permitted, although photographs of the upper region of the ladder were taken as part of Invenergy's incident investigation. The IBEX belt and Tuf-Tug cable that were installed in the tower were replacement components, as the failed IBEX belt and the Tuf-Tug cable involved in the fall event had been removed from the tower. The involved belt and cable were located at Invenergy's site, and were photographed prior to being transported to ESI's laboratory in Dallas, Texas (Figure 4). The belt and cable had reportedly been stored on a pallet after removal from the tower. In addition, the stored belt did not include the segment of belt containing failure location, as the failed ends had been previously removed from the belt.

Figure 4. Views of the Ibex belt (upper image) and Tuf-Tug cable (lower image) that were involved in the fall incident. These items had reportedly been stored, on the pallet shown, at the Invenergy wind farm site.

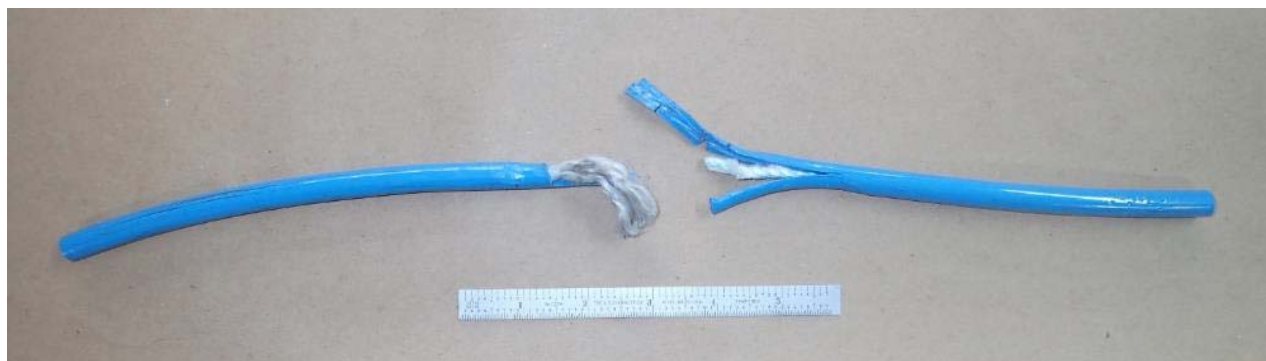
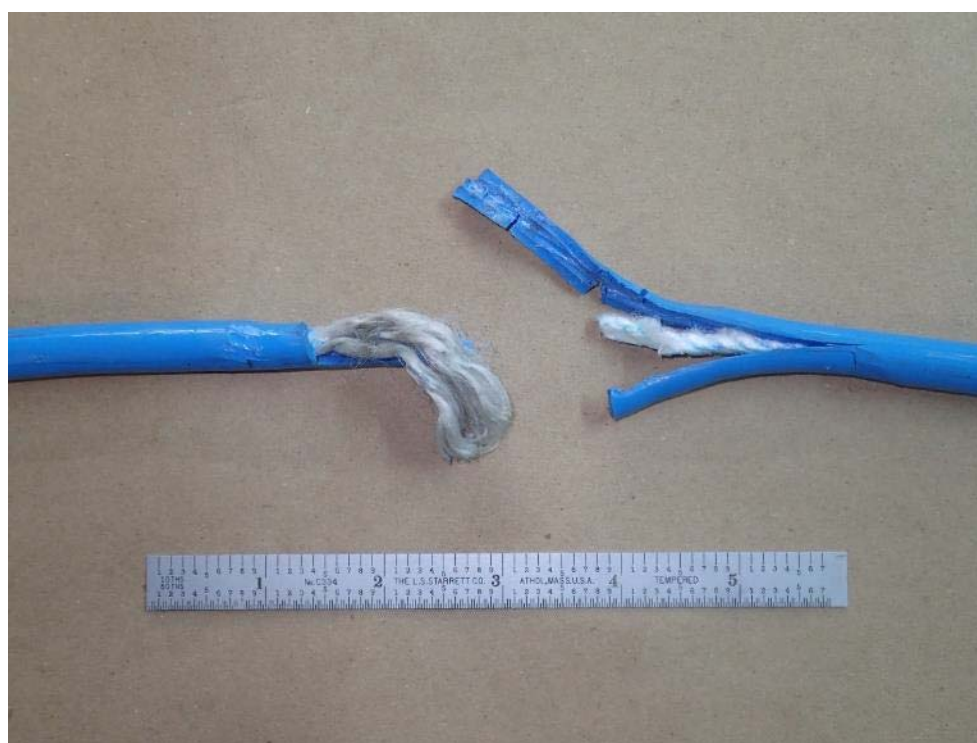
A segment of the IBEX belt that contained the failure location was available for examination; the two pieces making up the failed segment had been cut from the overall IBEX belt and transported to the ESI facility independent of the remainder of the belt (Figure 9). The belt examination included the use of a stereo microscope to look at surface features at low to intermediate magnifications, and images were taken by ESI personnel using a digital camera attached to the stereo microscope.

Figure 9. Views of the failed weld region of the IBEX belt that was available for examination during the first testing event at the ESI laboratory in Dallas, Texas. The outer ends of the pieces shown in the upper image had been cut to remove the failed weld from the remainder of the belt (which was stored at the Invenergy site).

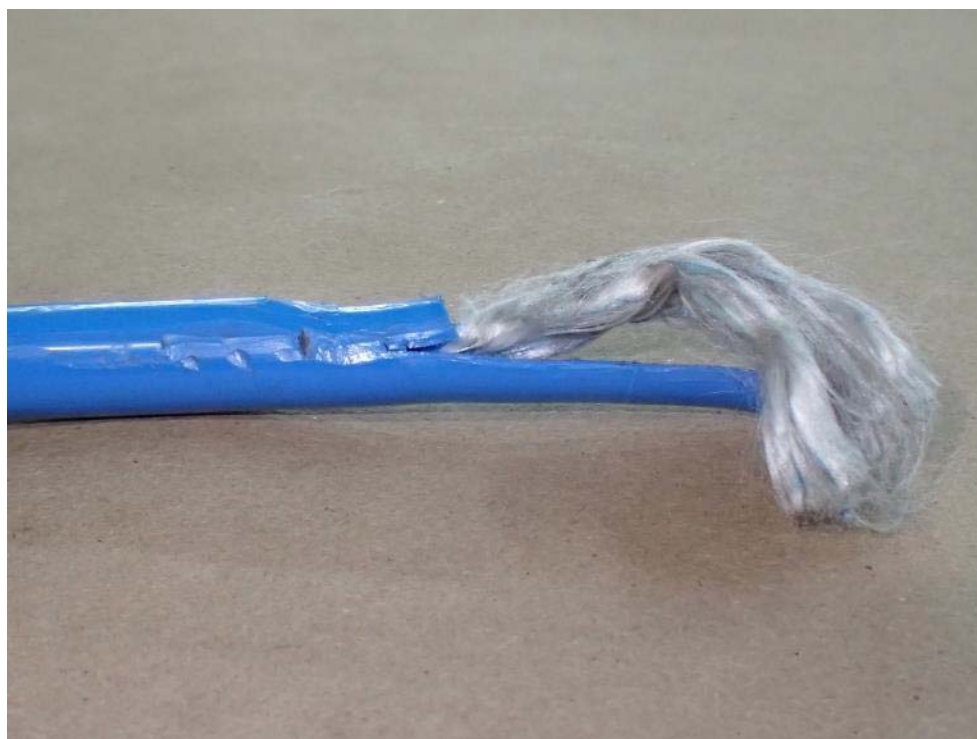
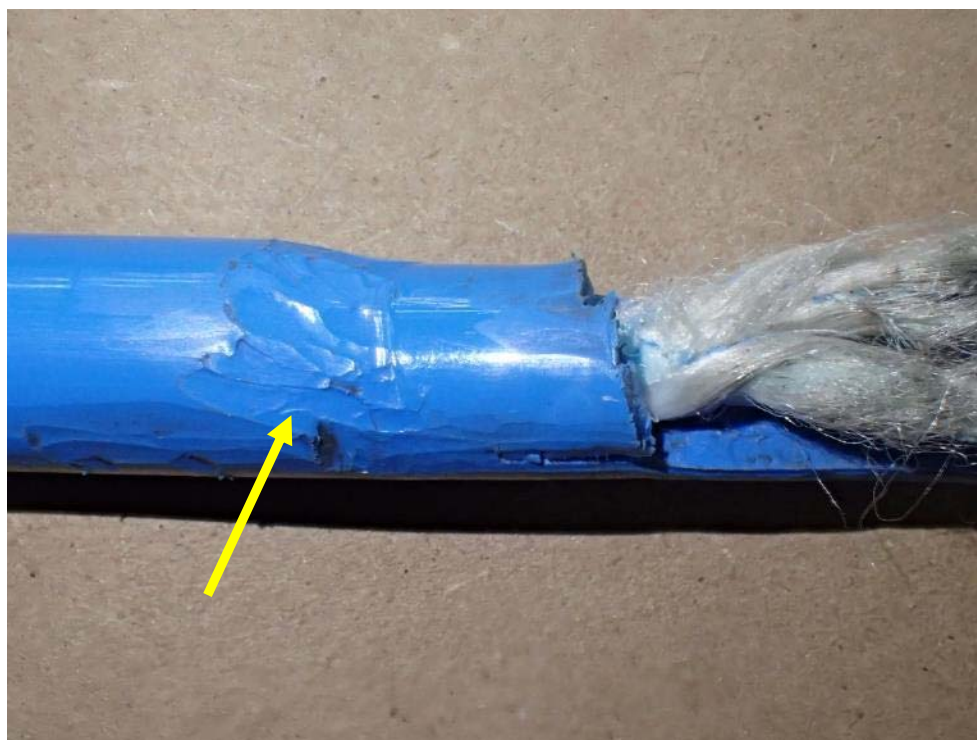
Close visual examination of the failure region revealed that the failure occurred at a weld (Figures 10 and 11). On one side the fiber core was frayed and appeared to be slightly dirty, and on the other side the fiber core was intact and with a cleaner appearance. At the failure location, the separation occurred in a stepped manner, with partial transverse separations at two (offset)

Figure 10. Additional close views of one side of the belt failure location. The surface cuts visible in the lower image are consistent with trimming of the belt after welding two ends together.

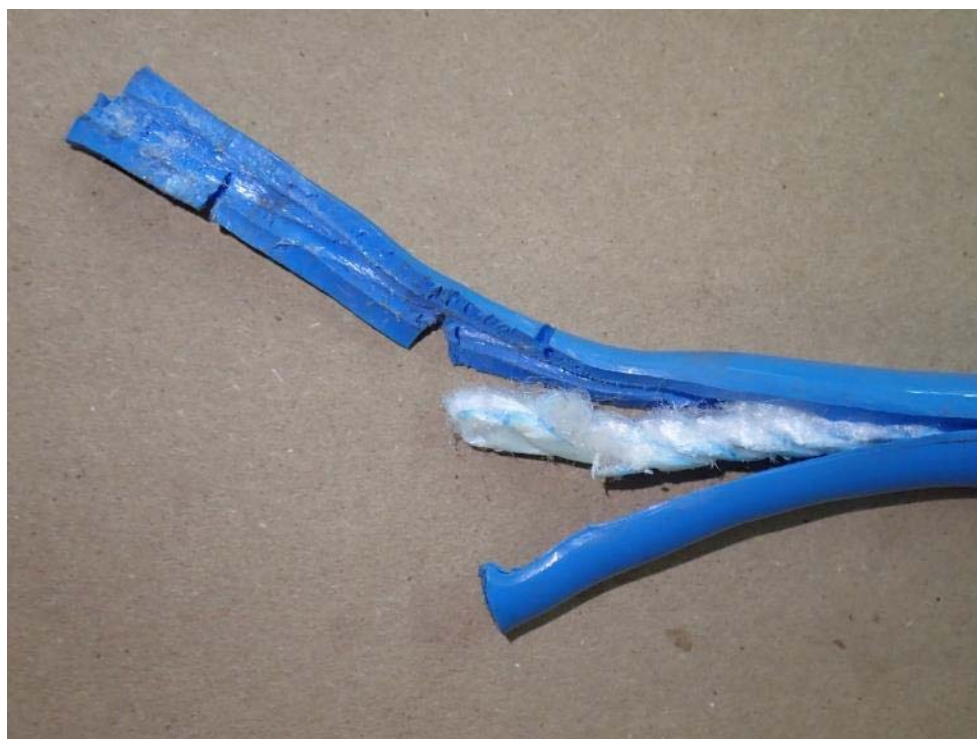
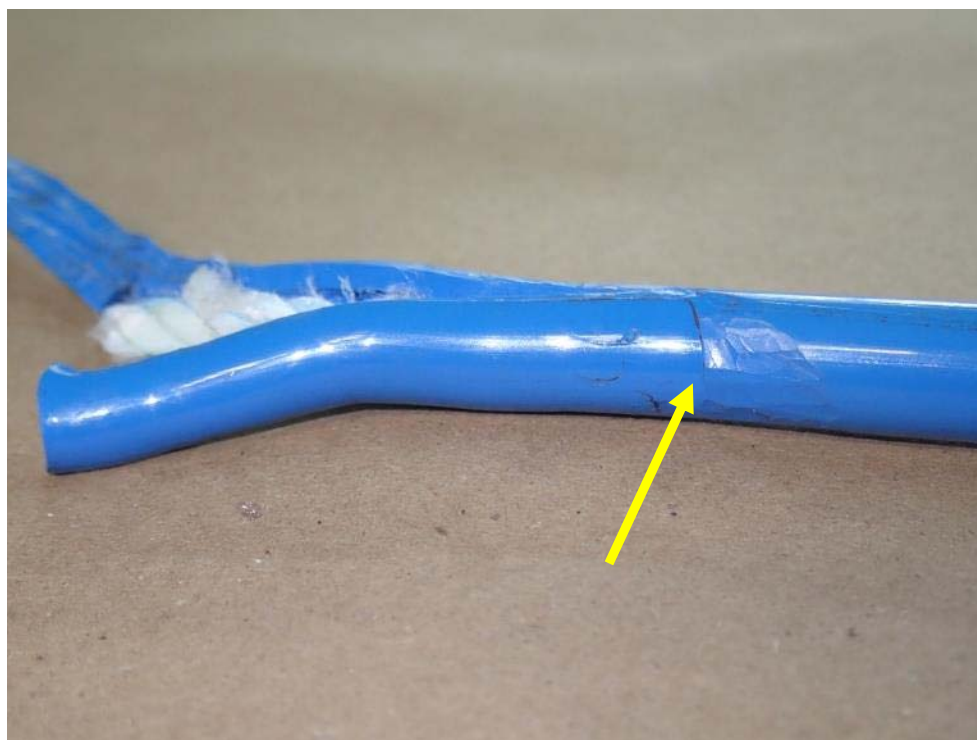
Figure 11. Additional close views of the other side of the belt failure location from that shown in Figure 10. The transverse line and surface cuts visible in the lower image are consistent with a weld seam and trimming associated with the welding process.

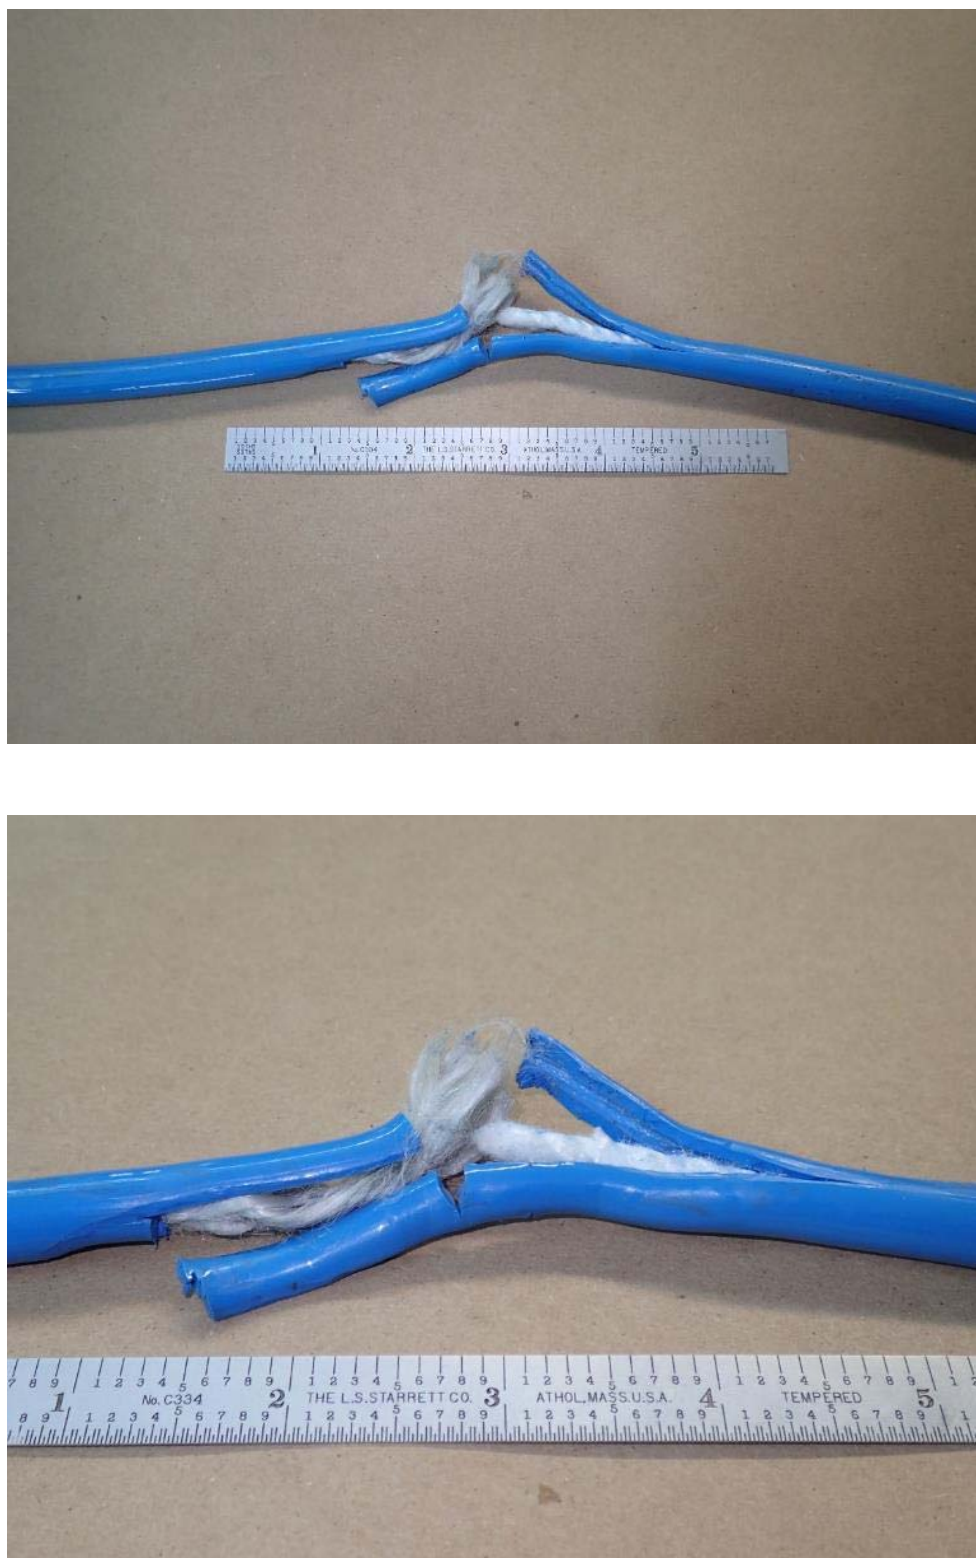
locations, and a longitudinal split that extended about three inches along the length of the belt (Figure 12). The polymer exterior was also permanently bent in the area of the failure.

Figure 12. Views of the two IBEX belt segments after repositioning in the approximate pre-failure configuration.

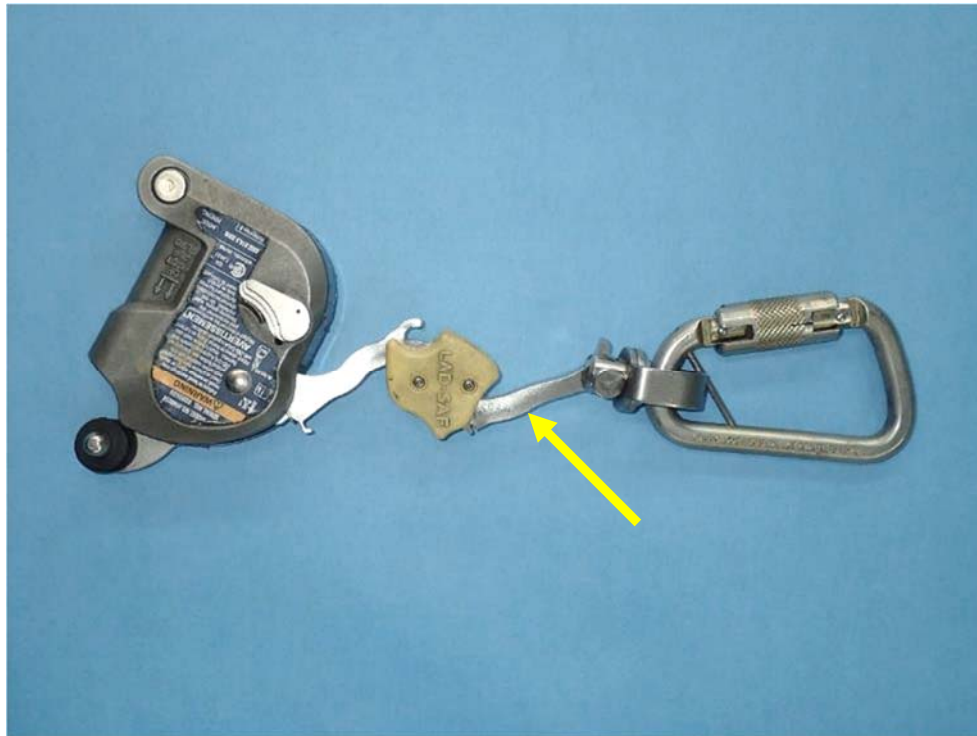
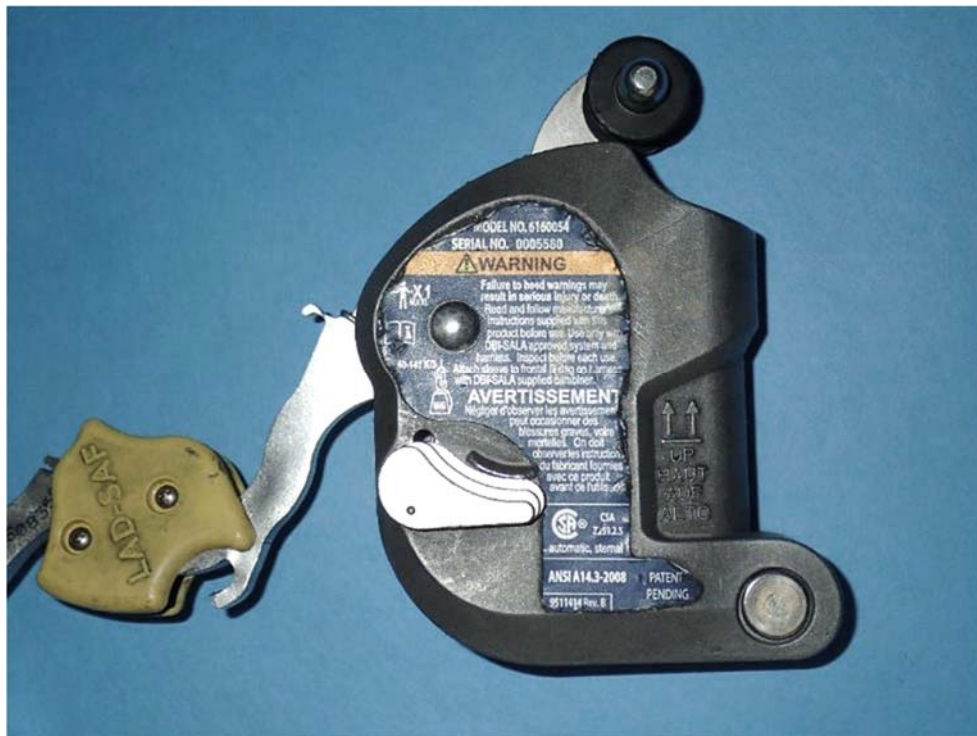
Mr. Moore's Lad-Saf X3 sleeve was available for visual examination at the ESI facility (Figures 13 and 14). Markings on the sleeve identified it as Model No. 6160054 with Serial No. 0005580. The sleeve included an attached carabiner, and the locking arm (energy absorber) was deployed (in a stretched condition). Aside from the deformed energy absorber, which was stretched to a length of approximately 5-3/8" (pin-to-pin) and slightly twisted, no other components exhibited evidence of deformation or cracking.

Figure 13. Views of the Lad-Saf X3 that Mr. Moore was reportedly using at the time of the fall incident, marked with Model No. 6160054 and Serial No. 0005580. In the upper image, the arrow indicates the location of the energy absorbing device, which has deployed (stretched).

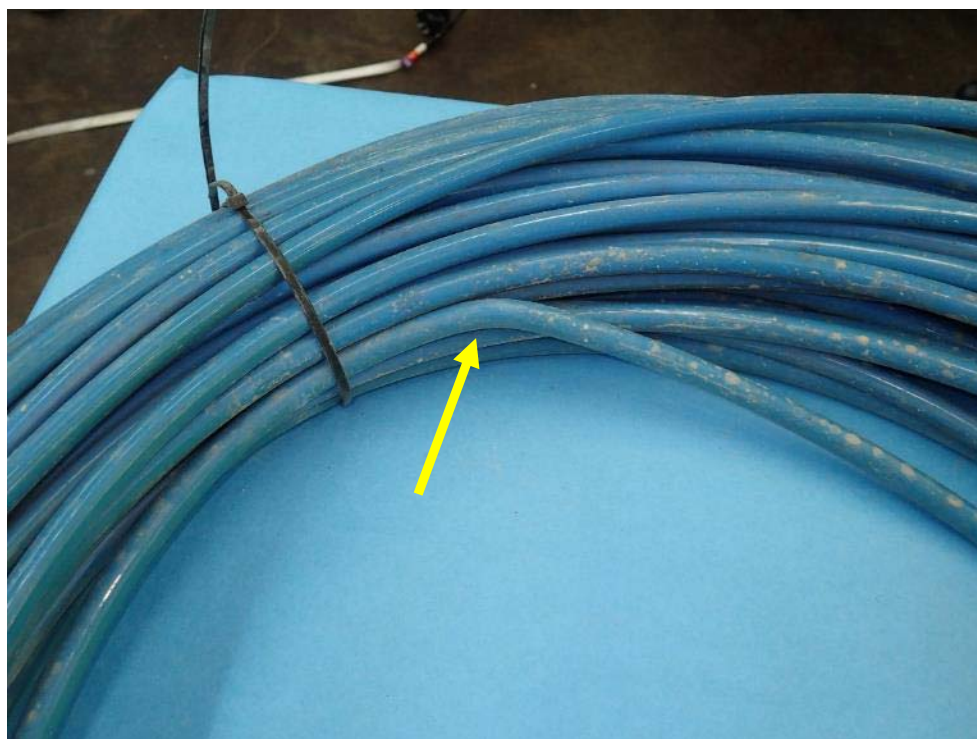
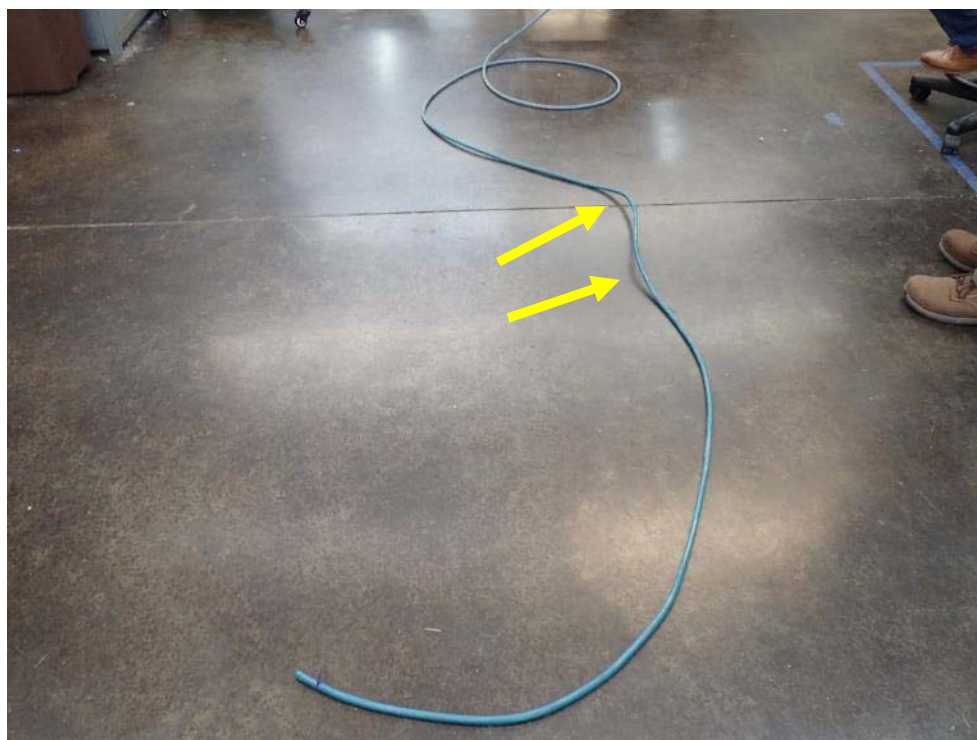
Figure 17. Views of two locations on the IBEX belt where deformation was present (permanent bends) are indicated by the arrows. The exact position of the belt at the time of failure, including the vertical location of the weld, was not determined.

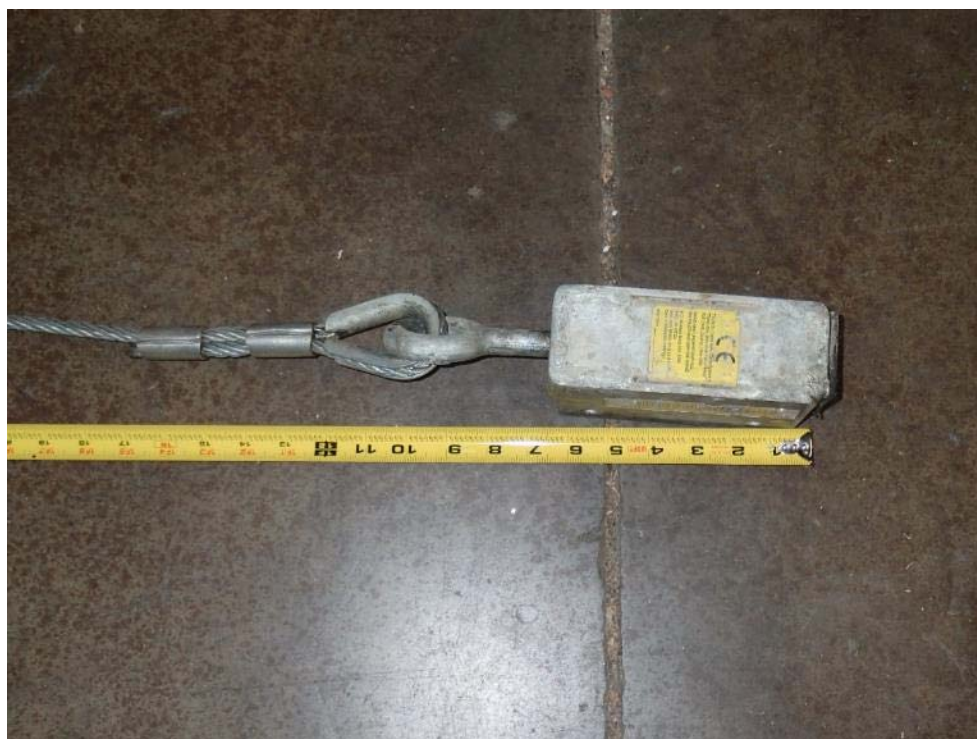
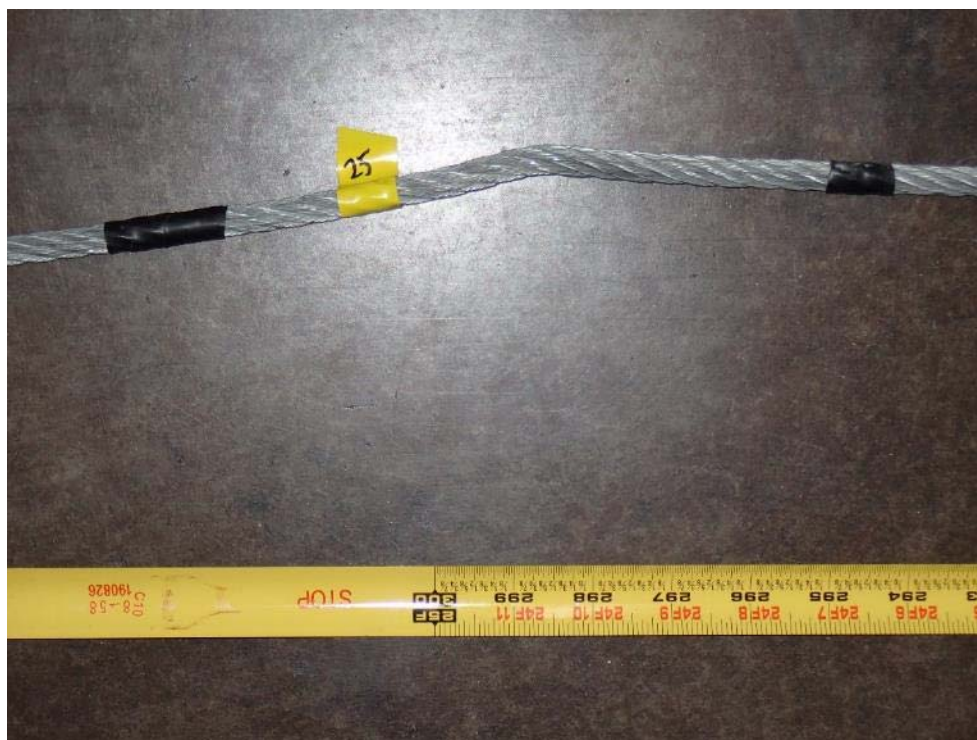
The upper end of the Tuf-Tug cable was laid out in order to measure the position of a marked kink in the cable (Figure 18). The cable was marked at five-foot intervals using yellow electrical tape, and the kink was determined to be approximately 25 feet below the upper fitting. The upper and lower ends of the cable were placed side-by-side and visually examined and photographed (Figure 19). The upper region of the cable was darker in color due to a slight residue of oily

Figure 18. Views of the upper end of the Tuf-Tug cable (upper image) and a marked location with a kink approximately 25 feet from the upper fitting.

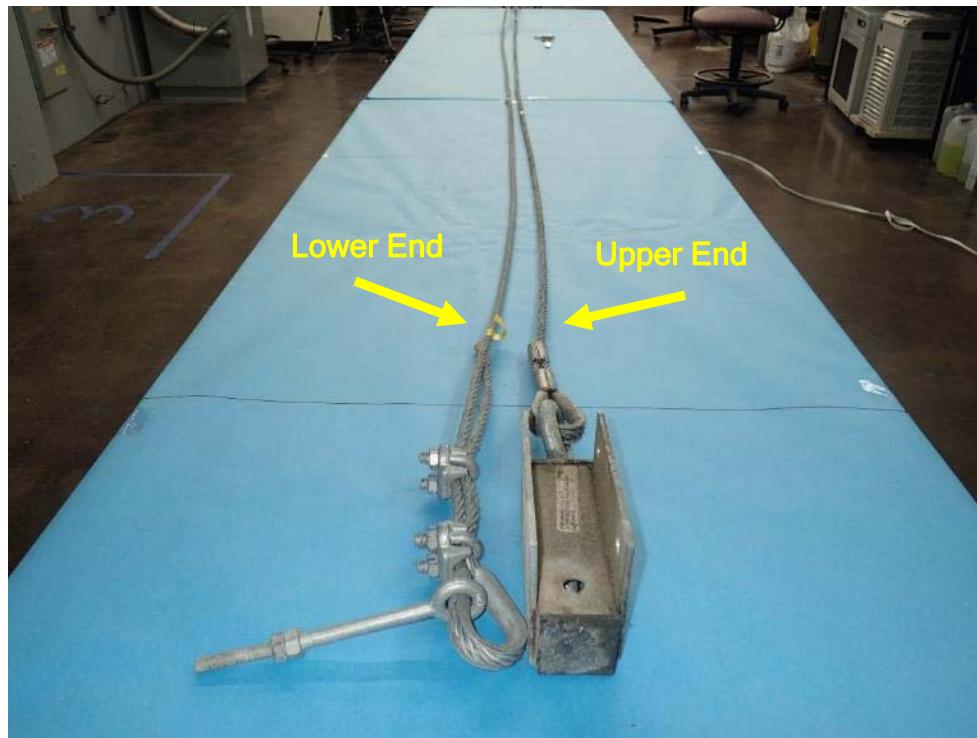
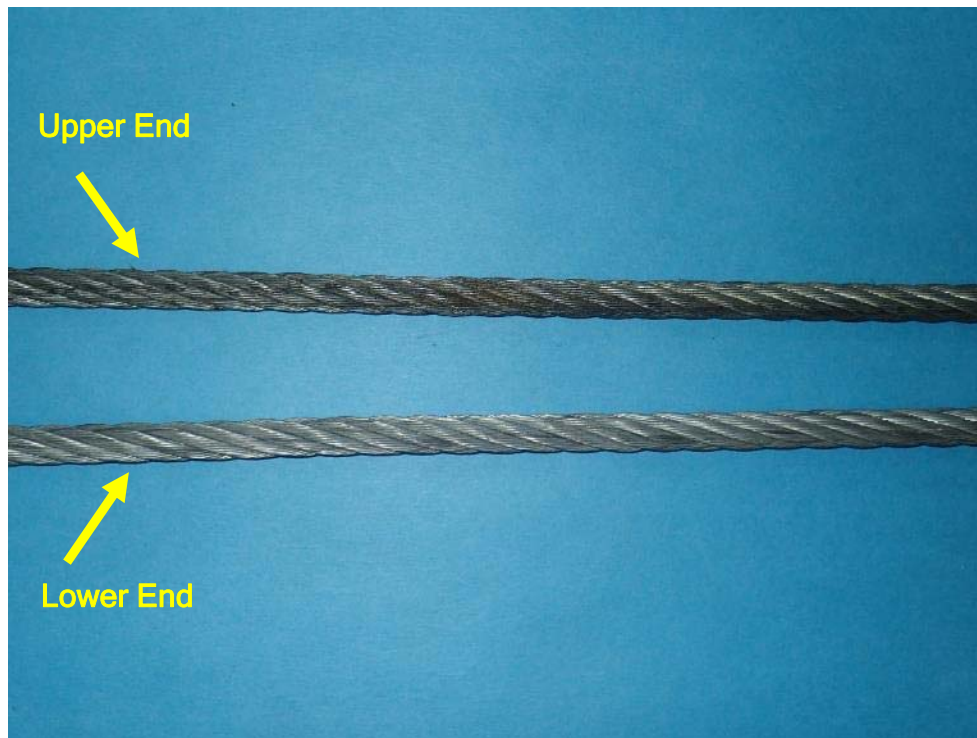
Figure 19. Views of the upper and lower ends of the Tuf-Tug cable involved in the fall incident. The upper end was darker in color as a result of a slight residue of an oily substance and deposits on the cable surface.

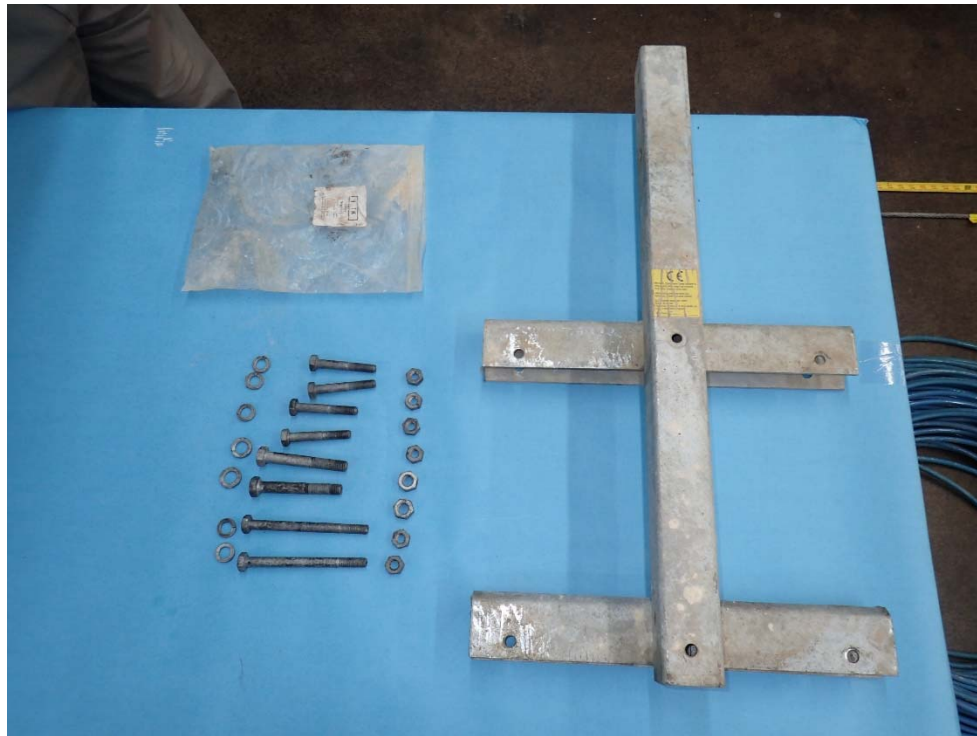
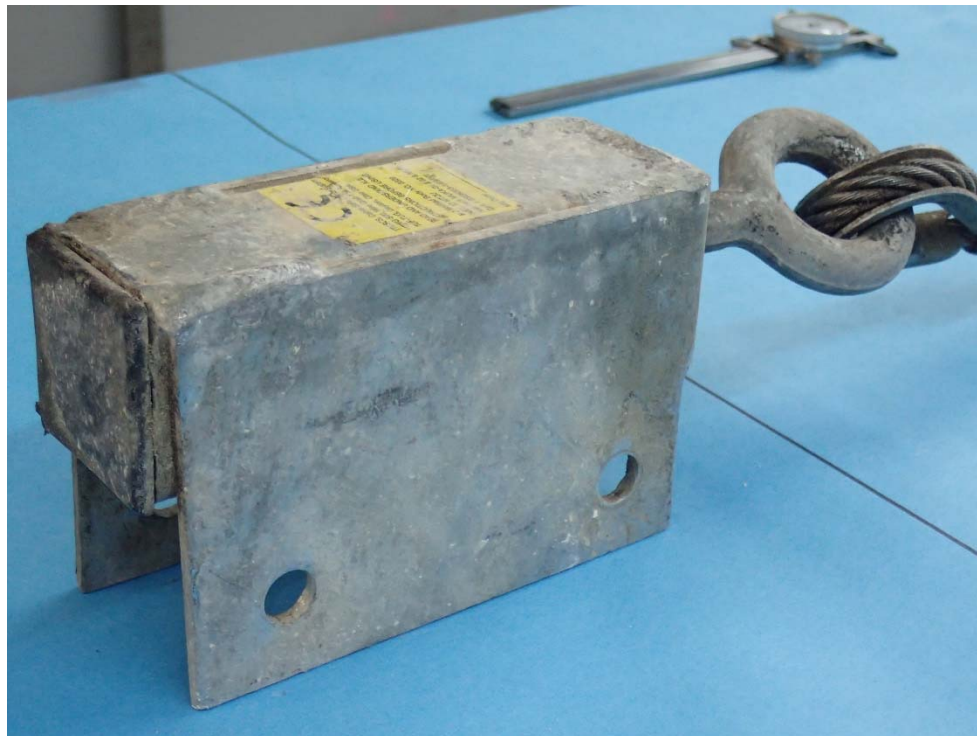
Hardware used to attach the Tuf-Tug cable to the tower ladder was stored and transported with the cable (Figure 21). The hardware components were visually examined and found to be intact with minor indications of wear.

Figure 21. Views of Tuf-Tug hardware components that were stored with the cable. The components were intact with minor indications of wear.

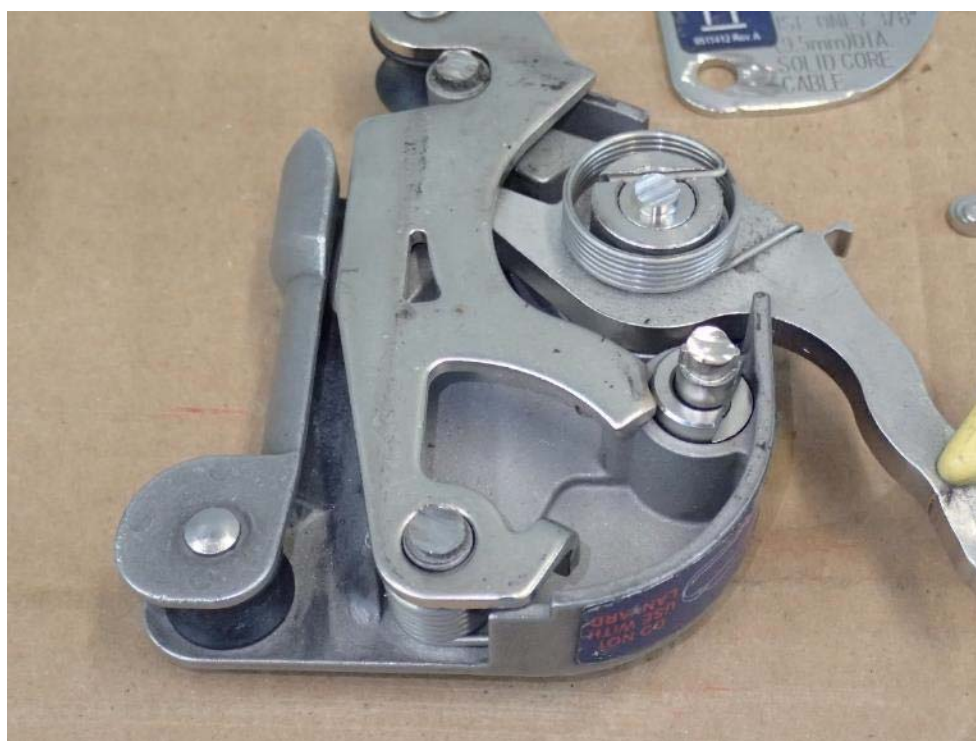
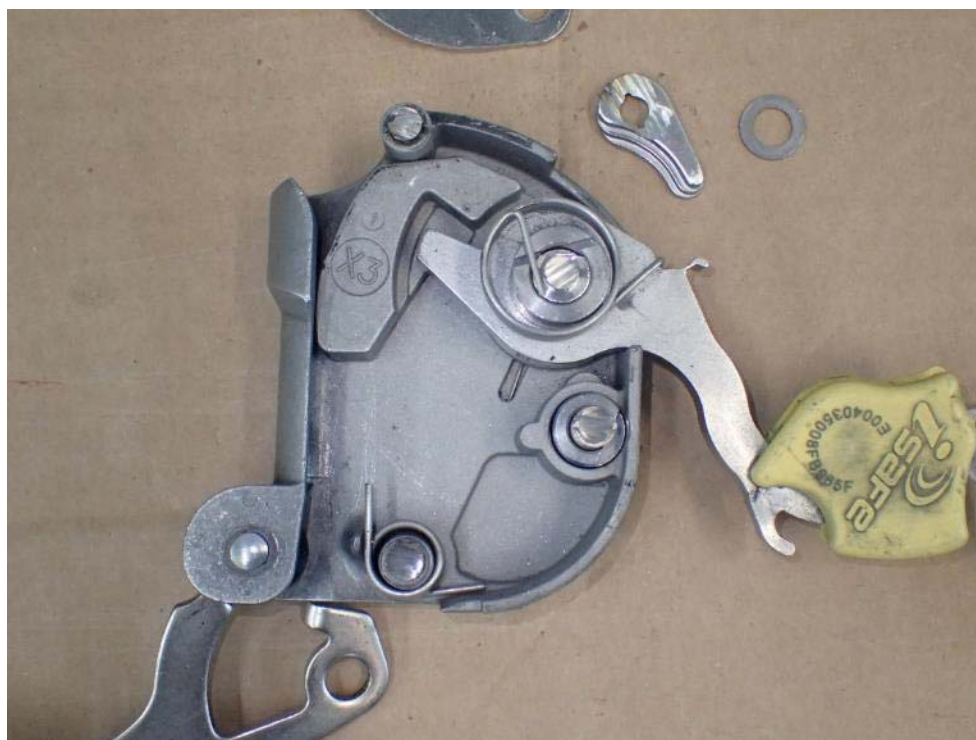
Figure 27. Views of the Lad-Saf X3 after removing the cover plate. Internal parts were intact and in place with no evidence of cracking.

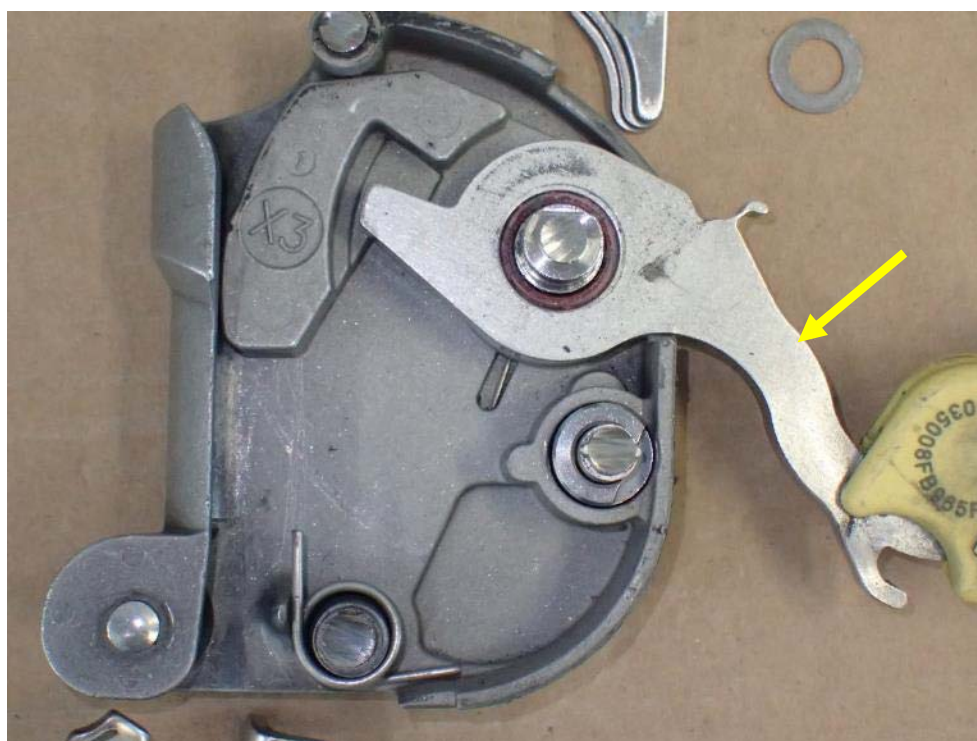
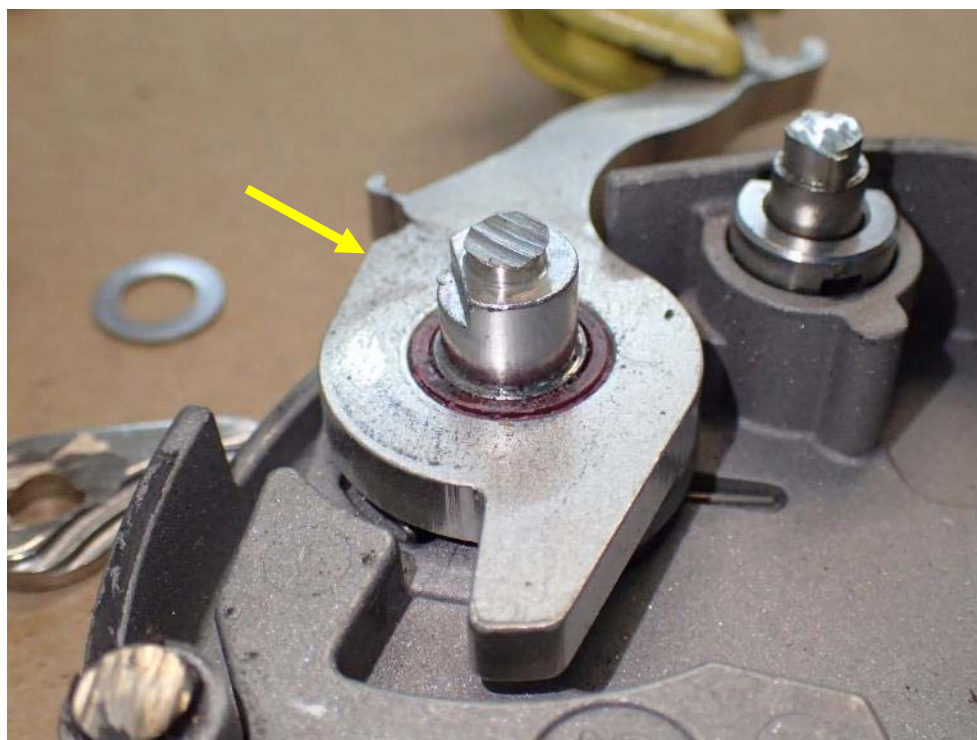
Based on a visual examination of the removed parts, the only part that appeared to exhibit evidence of deformation was the energy absorber (locking arm) that had deployed by stretching and slightly twisting (Figure 33). The pin-to-pin length of the deformed arm was measured to be 5.368".

Figure 28. Additional close views of the Lad-Saf X3 components during the disassembly process. Note that the energy absorber (indicated by the arrows) is expanded and deformed as a result of the deployment event.

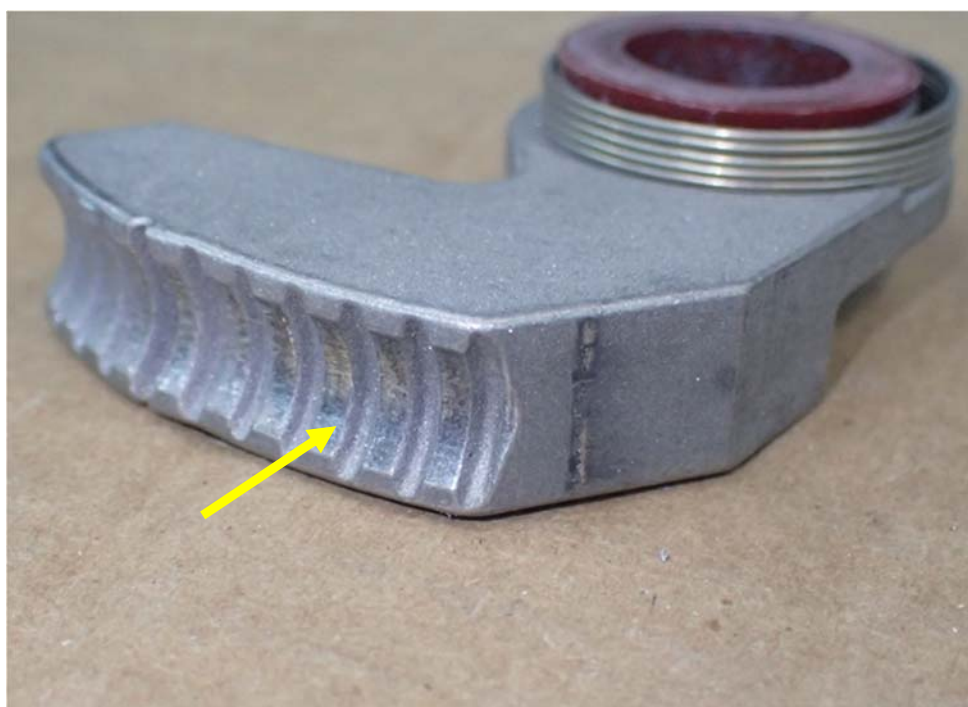
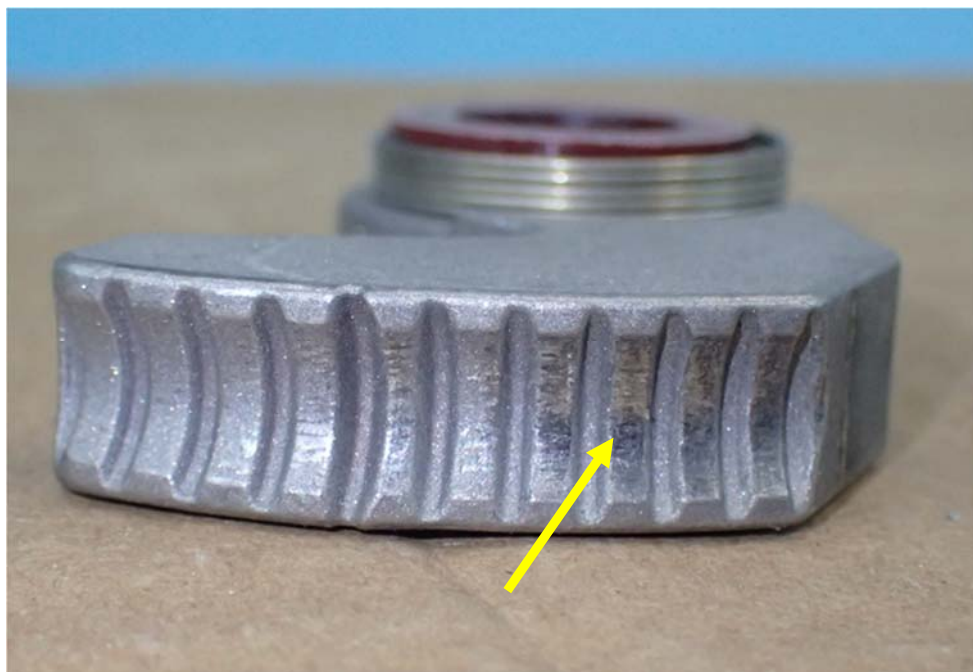
In order to further examine the individual components of the involved X3 sleeve, the rivets on one side of the device were ground off to permit disassembly of the sleeve (Figure 26). The exposed parts were removed sequentially and photographed (Figures 27 through 33). The internal parts were intact with no evidence of cracking. Small amounts of dirt or debris were observed on the surfaces of some parts, including the bushings and Teflon washer that guide the locking cam and locking arm components. The bushings also exhibited evidence of rubbing or scuffing on the edges (e.g., Figures 29 and 31). The locking cam surface that engages the cable exhibited witness marks (scuff marks or abrasions) that were consistent with the cam having engaged the cable (Figure 32).

Figure 32. Additional close views of the cam after removal from the Lad-Saf X3. The cam surface appeared to have witness marks as a result of contact with the cable (arrows).

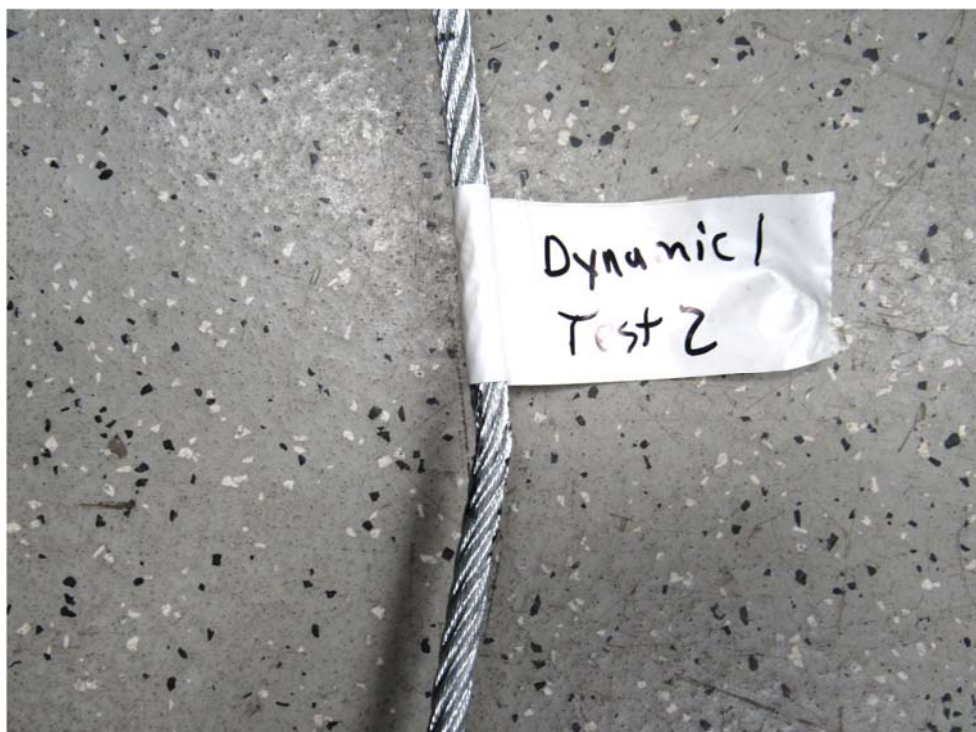
The first drop test resulted in the sleeve traveling 3.88 inches before locking on to the cable and a partial deployment of the energy absorber on the X3 sleeve that was measured to be approximately 5 inches. As a result of this test the cable was kinked in a similar manner to that which resulted from Mr. Moore's fall incident (Figure 34).

Figure 34. Views of the cable deformation produced by the first drop test performed by 3M on October 30, 2020 (upper image, provided by 3M), and the cable deformation produced by Mr. Moore's fall incident (lower image, provided by Invenergy).

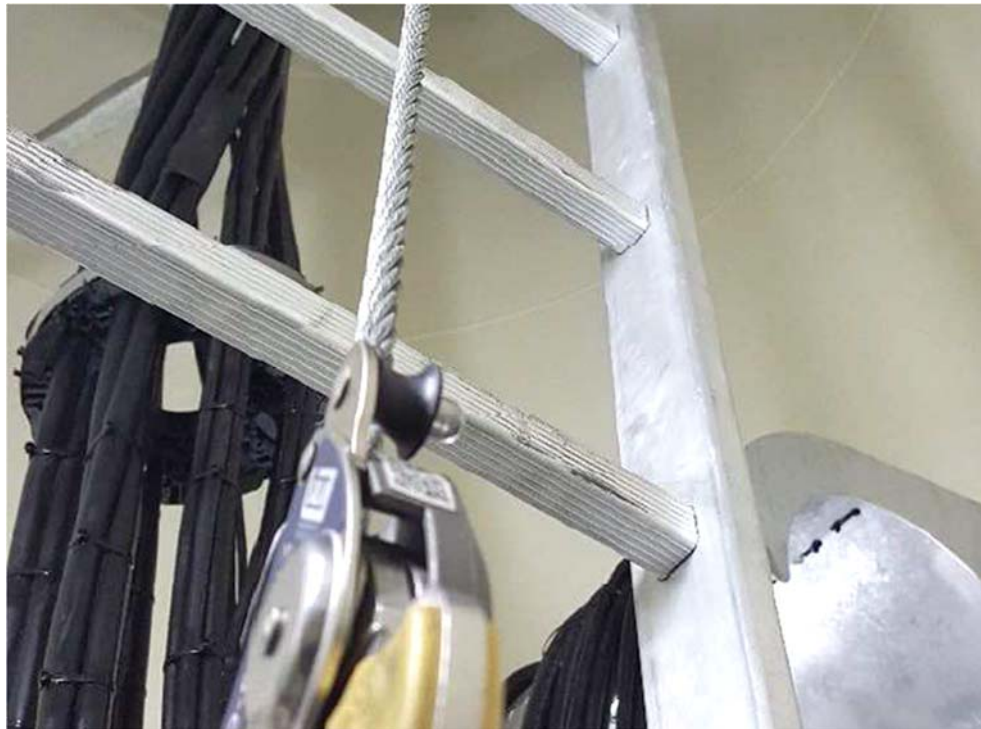
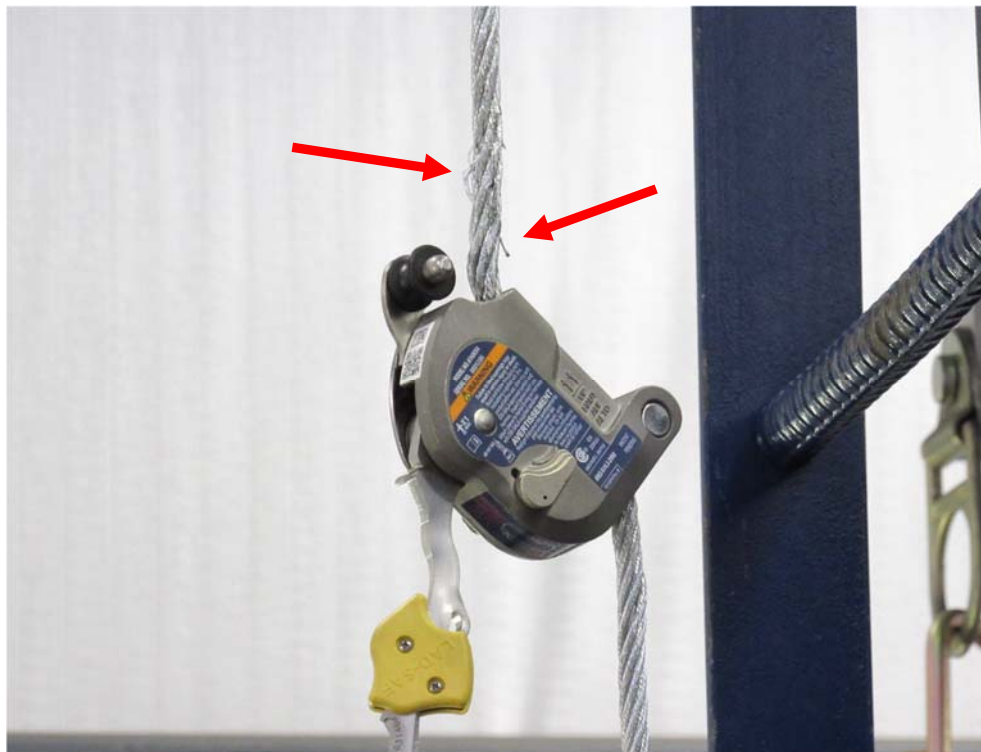
The extended drop test resulted in a full deployment of the energy absorber on the X3 sleeve that was measured to be greater than 6 inches. In addition, this drop test resulted in a higher degree of damage to the cable in the location where the sleeve was attached in comparison to the kink caused by Mr. Moore's fall incident (Figures 35 and 36). Measurements during the testing indicated that the sleeve slid approximately 2 to 3 inches down the cable during the loading event, thereby absorbing additional energy from the falling mannequin. Damage to the cable included excessive kinking and broken wire strands. Finally, the harness worn by the mannequin in this test, which was the same model harness worn by Mr. Moore, sustained partial tearing of the straps at the leg loops on each side of the mannequin. The peak load measured during this test was approximately 4,200 pounds.

Figure 35. View of the Tower 41 cable (upper image) showing the location where the subject X3 sleeve was locked onto the cable (image provided by Invenergy), and view of the X3 sleeve tested on October 30, 2020, by dropping an anthropomorphic mannequin 16-1/2 feet (lower image). In the lower image, damage to the cable is evident (image provided by 3M).
